**Shellharbour City Centre Detention Basin**  
*Operations and Maintenance Plan*  
Final

Client: Shellharbour City Council

**Molino Stewart Pty Ltd**

December 2021

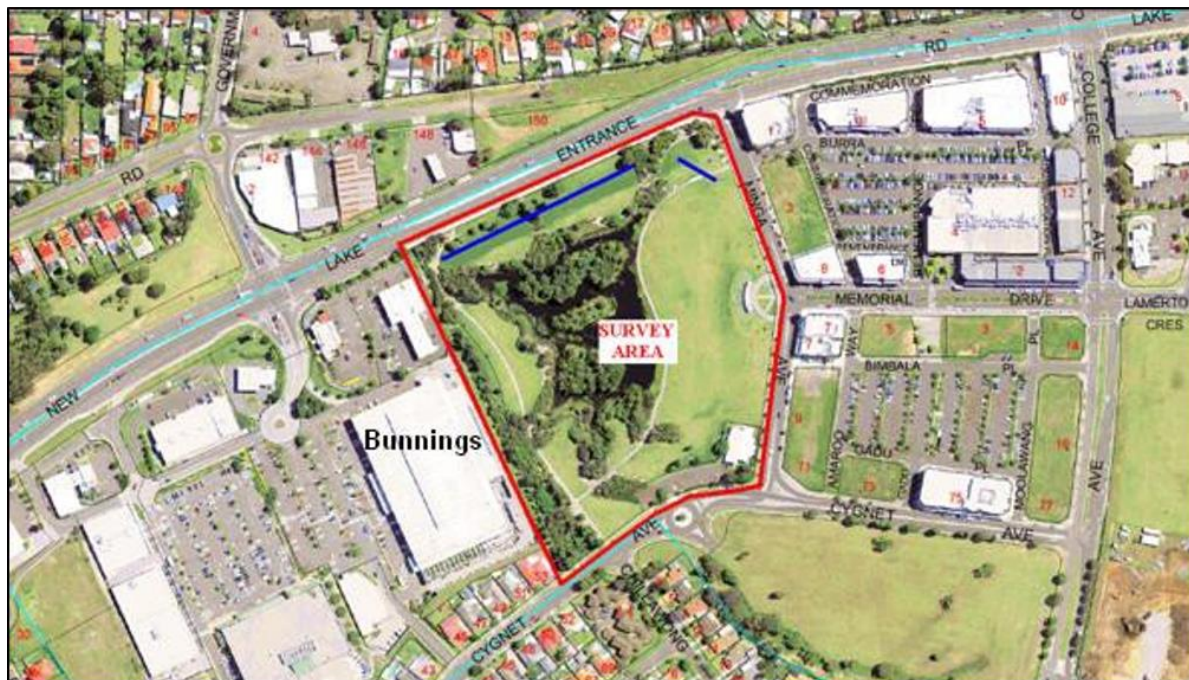
Figure 3. Layout of the Shellharbour City Centre Detention Basin

The layout of the basin is provided in Figure 3, while its main features are summarised in Table 1. For a full list of the key basin data, including design drawings and site access map, refer to Appendix B.
