**Shellharbour  
City Council**

**Shell Cove Detention Basin**  
*Emergency Plan*  
Final

# Dam Summary Information Sheet

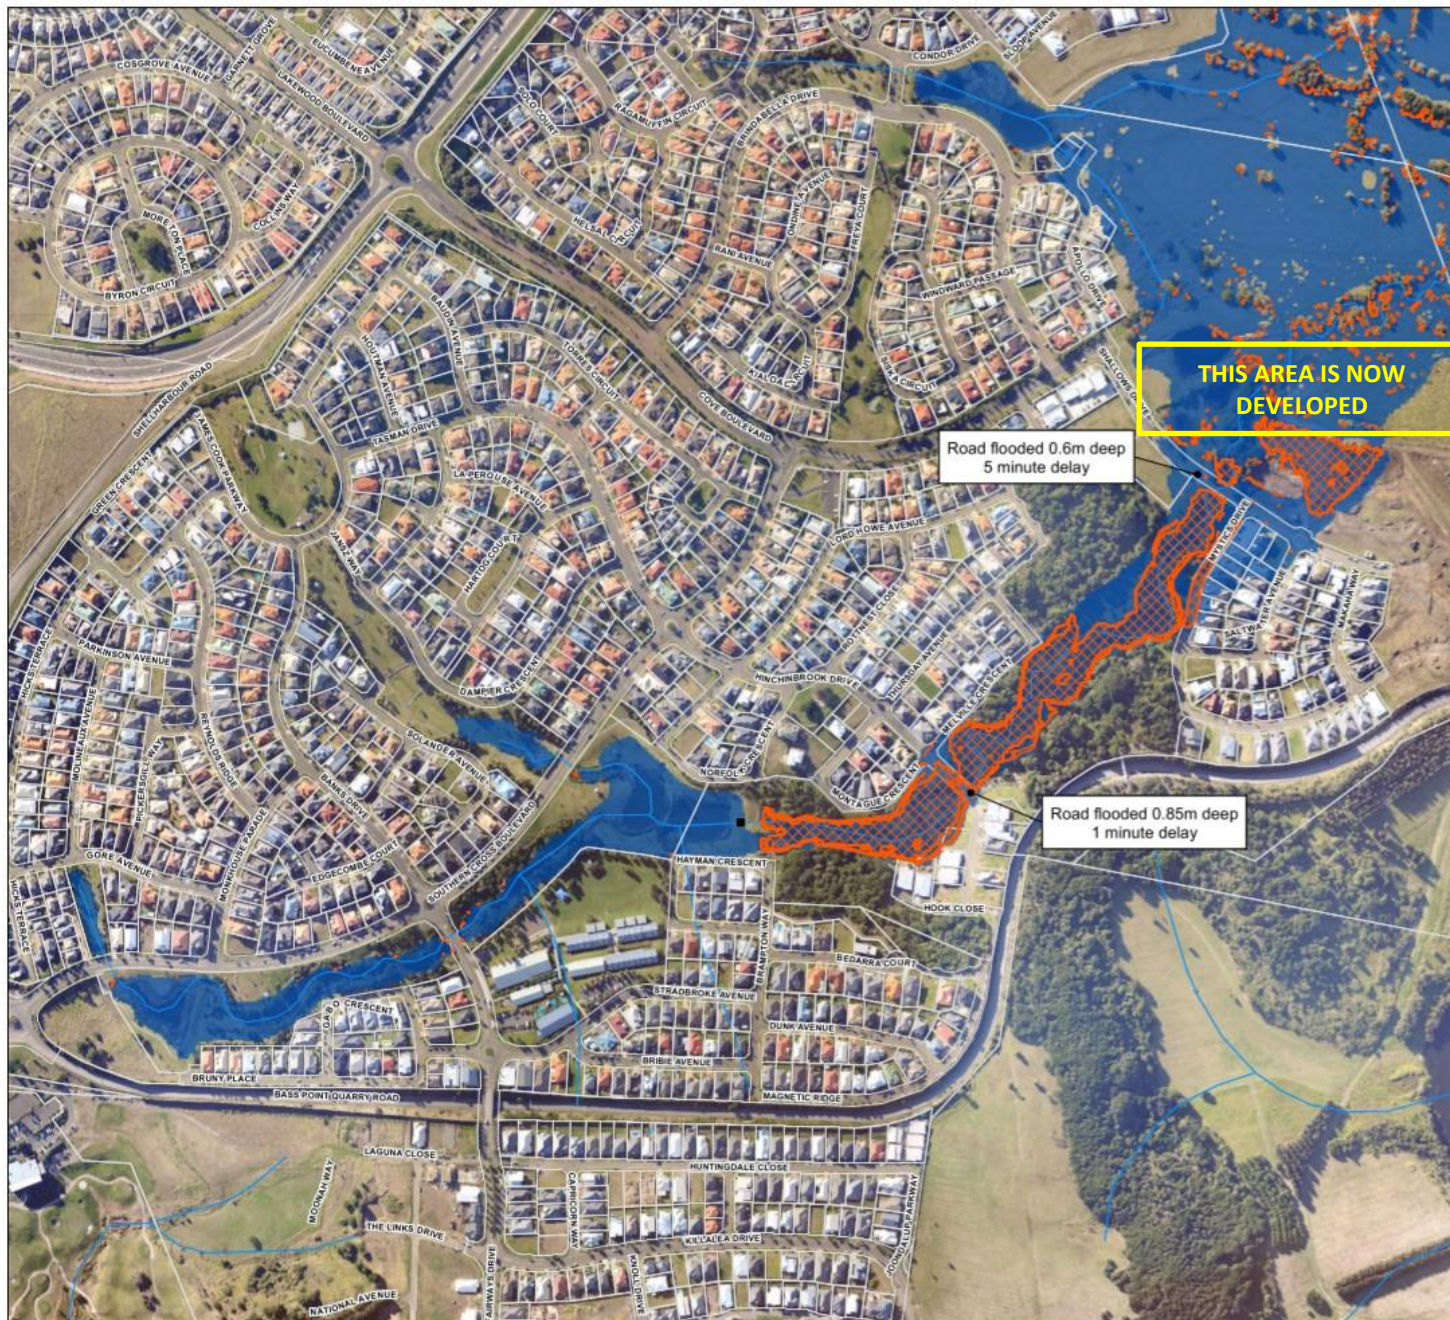
## 20,000yr ARI Event Dam Break Incremental Effects

SHELL COVE DAM BREAK STUDY

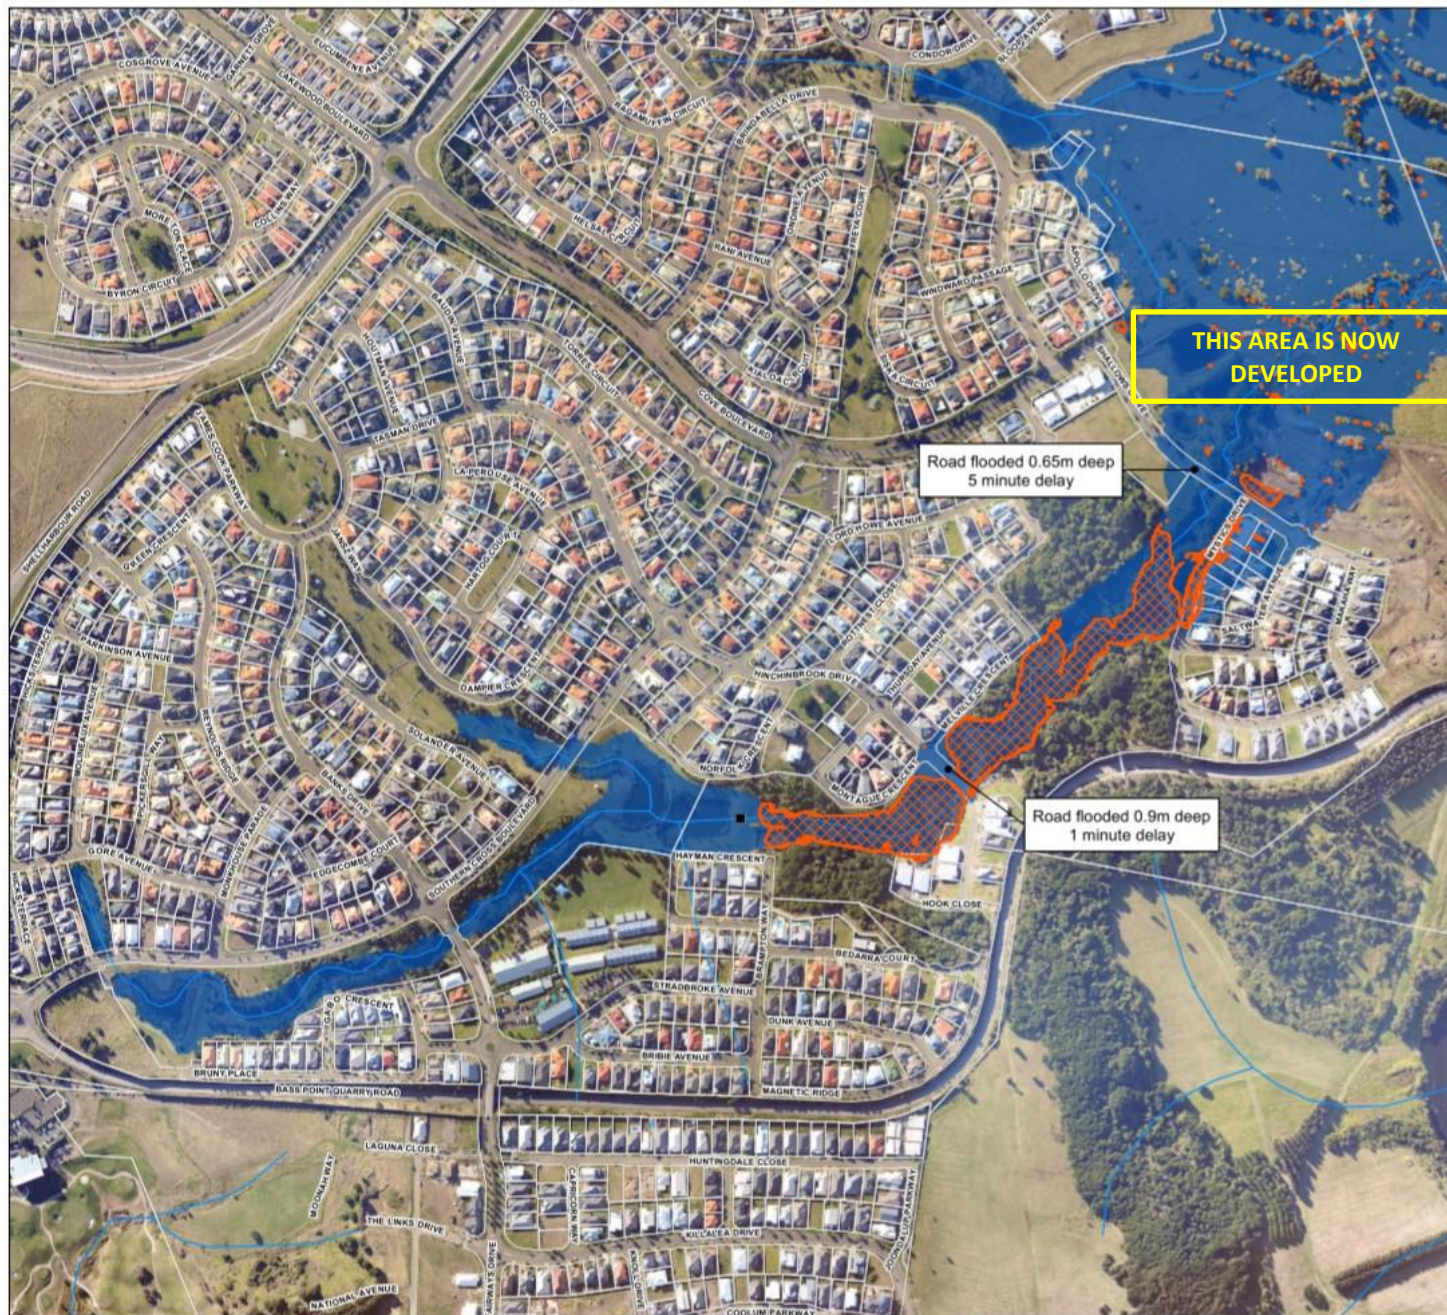
## 100,000yr ARI Event Dam Break Incremental Effects

SHELL COVE DAM BREAK STUDY

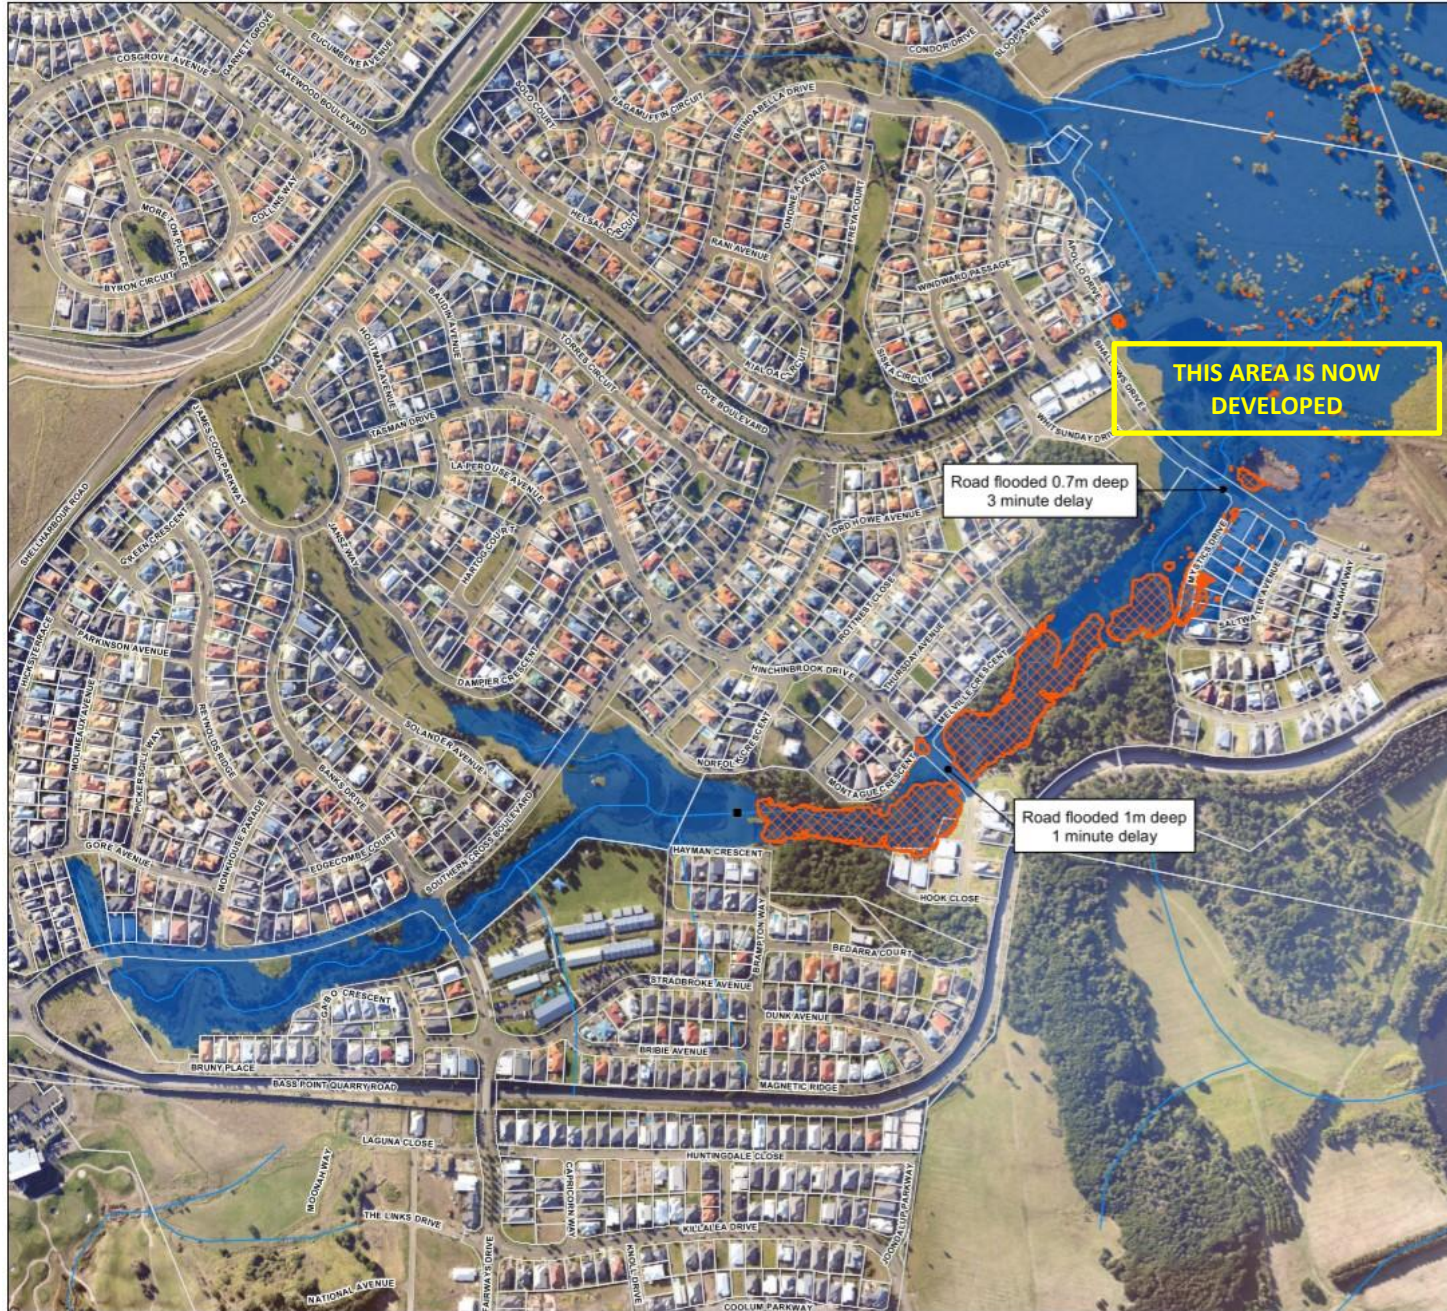
## PMF Event Dam Break Incremental Effects

SHELL COVE DAM BREAK STUDY
